# **Navajo Abandoned Uranium Mine**

## **Site Screen Report**

**Mine Name: Sjodin claim  
Mine ID: 850**

**April 2012**

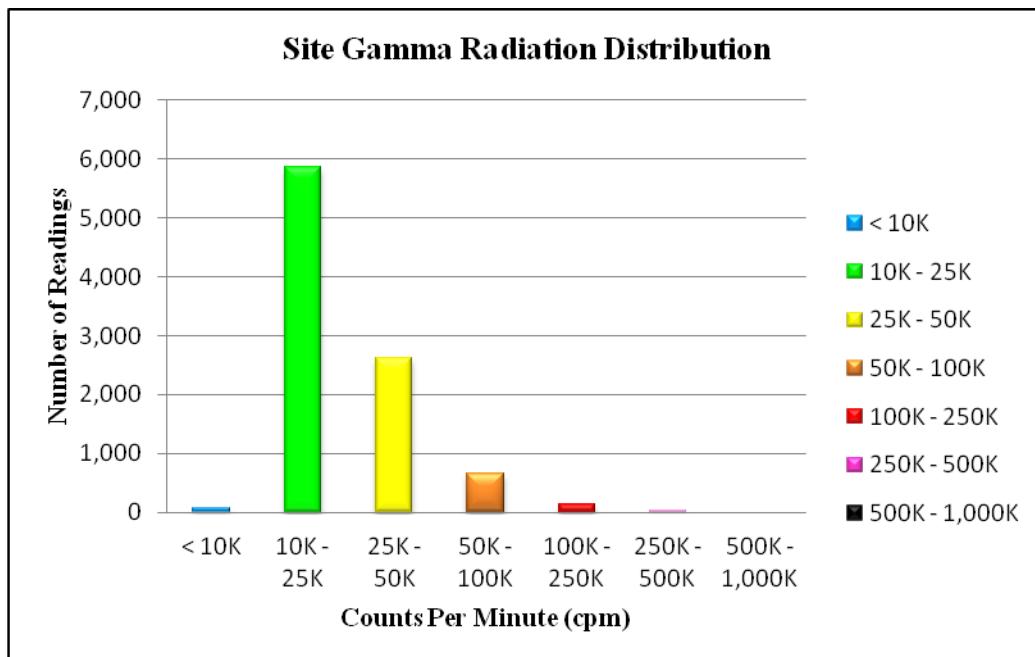
**Highest gamma radiation measurement:** 331,646 counts per minute (cpm)

**Background Average:** 11,897 cpm        **Two Times Background:** 23,794 cpm

A total of 9,338 gamma radiation measurements were collected from the mine site, ranging from 8,232 cpm to 331,646 cpm. Maximum levels of approximately 330,000 cpm were found in the vicinity of the waste rock. The measurements are represented in Figures 1 and 2.
